Removing the ring stuck on finger with a high speed motor: a case report

M. Fethi Ceylan¹, Haldun Topgöl²

¹Department of Orthopedics and Traumatology, İnönü University Turgut Özal Medical Center, Malatya,

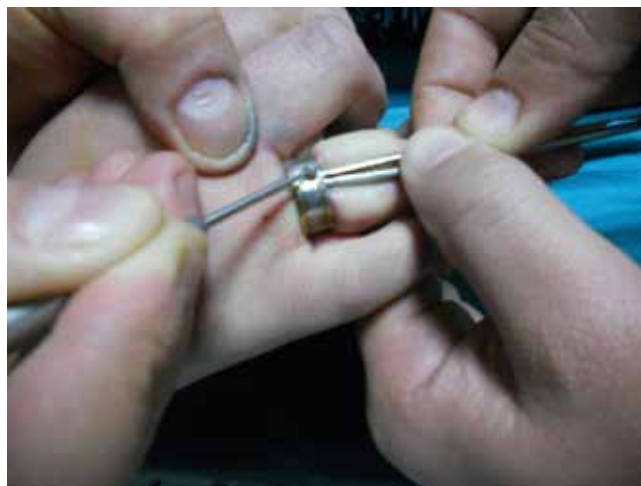
Figure 3. Cutting the ring with the high-speed motor.

this ring, which could not be removed by conventional methods. First, the outer link of the ring was cut off. Then, the wider and thicker ring on the inside of the ring was cut out during a 10-minute period by placing a forceps between the ring and the finger to prevent injury to the patient's finger and cooling intermittently with water to avoid thermal injury (Figure 3,4).

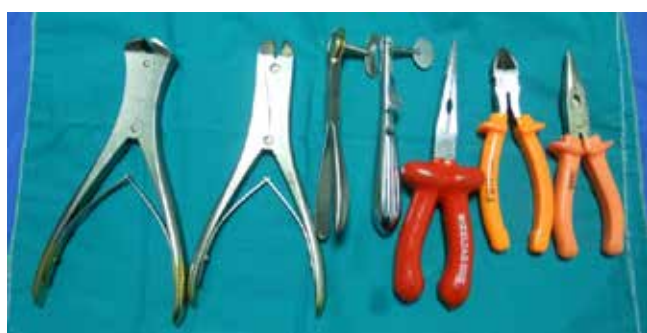
Figure 2. Tools used to remove the ring.

A 17-year-old female patient applied to the emergency department at around 20:00 in the evening because of the swelling and pain in her finger caused by a ring. The patient's complaints began two days ago and gradually increased. During the examination of the patient, it was seen that there was an interlaced double ring, which was wider and thicker than normal, on the 4th finger of the right hand. There was redness, swelling, and temperature increase on the finger in the distal part of the ring (Figure 1). It was seen that the ring on her finger was stuck to the highest degree. With the help of lubricants, the extraction was tried to be removed without being cut but this procedure was not successful. Later, although the wire cutter, pliers, Gigli wire, and ring cutter were used, the ring could not be cut (Figure 2). The patient's finger was fairly stretched and had the risk of developing compartment syndrome. A diamond tip high-speed motor used in spinal surgery was used to remove
